# Manhole Inspection Summary

Manhole # S51O\_\_067MH

Insp Date: **9/15/09 10:00 AM**

**Location** Address: **1111 S.Linwood St.**

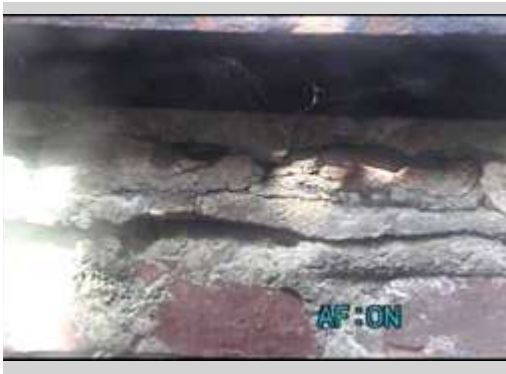
Defect 3

Condition: ☐ Sound ☐ Cracked ☐ Root Intrusion ☐ Loose Brick ☒ **Deteriorated**

deteriorated chimney

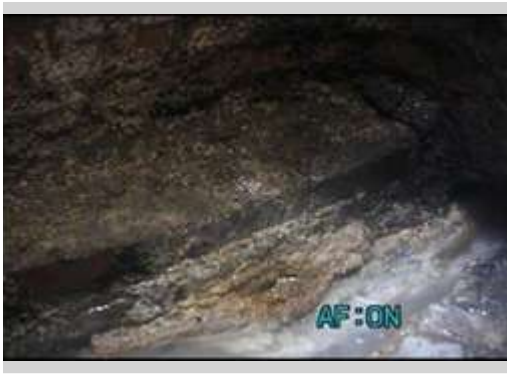
Defect 2

Condition: ☐ Sound ☐ Cracked ☐ Root Intrusion ☐ Deteriorated ☐ Leaks ☒ **Debris**

grease in channel

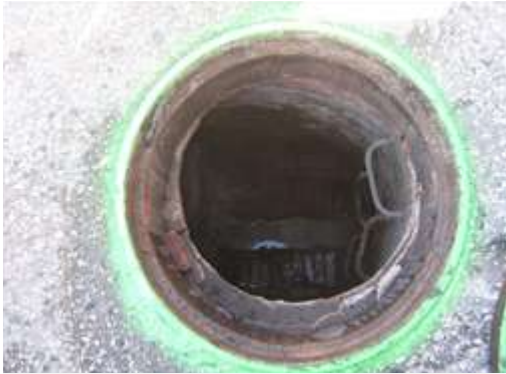
Defect 4

Offset: **2** (in.)

frame offset

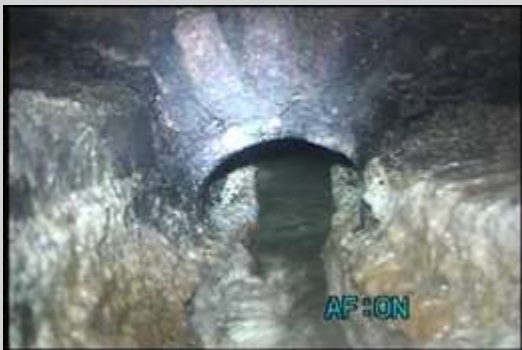
12 O'Clock Outflow

Pipe Height: **8.4** (in.) Rod and Bar (Angled)  
Pipe Material: **Clay** ☐ Pipe Lined  
Invert Depth: **9.10** (ft.) Flow Characteristics: **Slow**  
Deposits: ☐ None ☐ Mud ☐ Sludge ☐ Debris ☒ Grease  
Silt Depth: **5** (in.) Deposits Extent: **Heavy**  
Infiltration: **None** Pipe Seal Cond: **Sound**

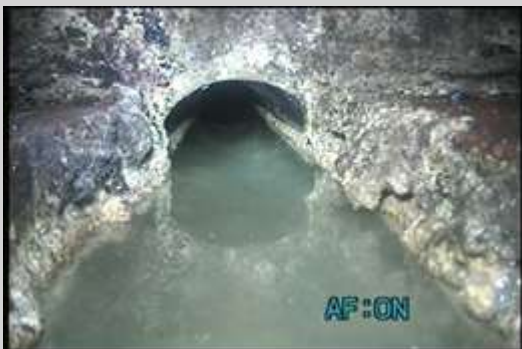
3 O'Clock Inflow

Pipe Height: **8.4** (in.) Rod and Bar (Angled)  
Pipe Material: **Clay** ☐ Pipe Lined  
Invert Depth: **8.76** (ft.) Flow Characteristics: **None**  
Deposits: ☐ None ☐ Mud ☐ Sludge ☐ Debris ☒ Grease  
Silt Depth: **2** (in.) Deposits Extent: **Light**  
Infiltration: **None** Pipe Seal Cond: **Sound**
